Geophysical and Geotechnical Examination of Structural Failure in Federal University Otuoke, Nigeria

Ibe, S.O. and Anekwe, U. L.

Department of Physics, Federal University Otuoke, Nigeria

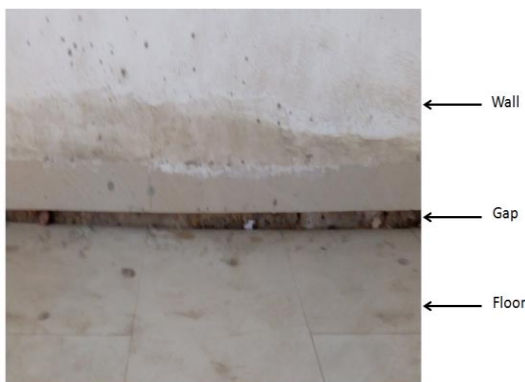
Fig. 1: Gap Between the Wall and Floor of a Building in the University

Profile AB is in the vicinity of a long building of class rooms located approximately at latitude $04^{\circ} 47' 27.68''$ N and longitude $06^{\circ} 19' 14.58''$ E. The building is affected by gaps between its walls and floors. The defect which appears like a trough has a maximum gap of about 5.0 cm at the centre and gently decreases to show little gap (≈ 2.0 cm) at the northeastern end and no gap at the Southwestern end of the building.

Figure 9. The figure suggests that a less dense soil layer (clay), underlying the ‘trough’ is flanked by compacted soil layer. Owing to high moisture content (34.33 %) and swell (101.2 %) of the clay relative to the adjacent soil layers the water seeping into the former caused it to swell during wet season resulting to enormous forces which lifted the tiled floor up. The clay lost its water during dry season and its shrinkage caused the subsidence of the floor resulting to the observed gap between the floor and the wall.

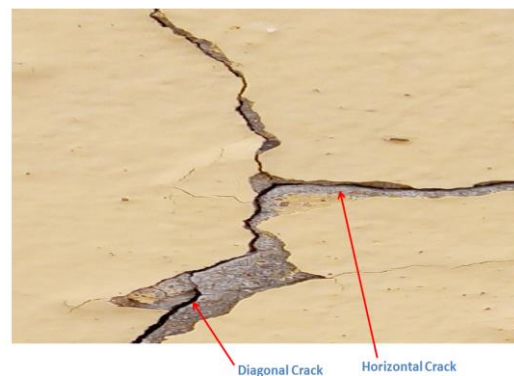
Fig. 2: Diagonal and Horizontal Cracks on the Wall of a Laboratory in the University

affected by both diagonal and horizontal foundation based cracks. The result of the 2-D electrical resistivity tomography data along profile CD (Figures 6) suggests the existence of dense/compacted soil almost at the centre of the spread, flanked by loose (low density or uncompacted) soil. The compaction most likely is as a result of regular usage of the place than its surroundings by heavy duty vehicles, prior to construction work, and/or deposition of building materials, such as coarse soil which was covered by sandfill when the entire place was prepared for building construction work.

The diagonal crack directly overlies B3 while the horizontal part overlies B2. This suggests that the cracks originated from uneven or differential settlement of the building. B3 offered more resistance to the downward movement (settlement) of the building than B2. That is, the crack most likely originated at the foundation of the building overlying B3 as 'diagonal crack' due to differential resistance to its settlement at B3, B3 and B4 and this crack was transmitted to other parts of the building overlying B2 as 'horizontal crack'.

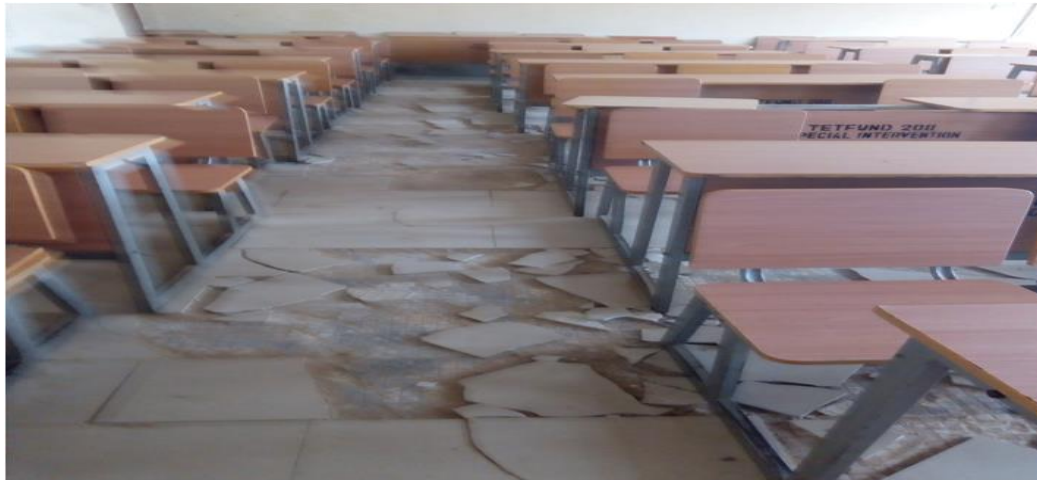
Fig. 3: Floor Cracking in a Classroom in the University

Profile EF is in the vicinity of a long building of class rooms located approximately at latitude $04^{\circ} 47' 29.95''$ N and longitude $06^{\circ} 19' 16.74''$. The building is affected by floor creaking which was sometimes accompanied with popping sounds.

The geotechnical parameters obtained from the soil samples collected from C2, C3 and C4 along Profile EF (Figure 7) suggest low values of bulk densities and specific gravity of the soil layers directly underlying the building's floor. Results of the tests showed that the range of the volumetric increase of the soil samples is 98.75 – 106.3 % (Table 1) for the clay soil directly underlying the building. According to Gibbs and Holtz (1956), soils with free swell values of 100% or more are associated with clays which could swell considerably when wetted. Clay particles are called layer silicates as the lattice structures form layers so that many clay particles resemble minute fish scales (Graymount, 2006). As a result some clays have an enormous surface area per gram. The large surface area of the clays combined with the electrostatic attraction between water and clay can result in enormous forces in the process of swelling and shrinkage of clays (up to 10,000 atmospheres of pressure), such that the swelling of clay, can lift structures off their foundations (Graymount, 2006) and its shrinkage can cause partial subsidence of the structure.

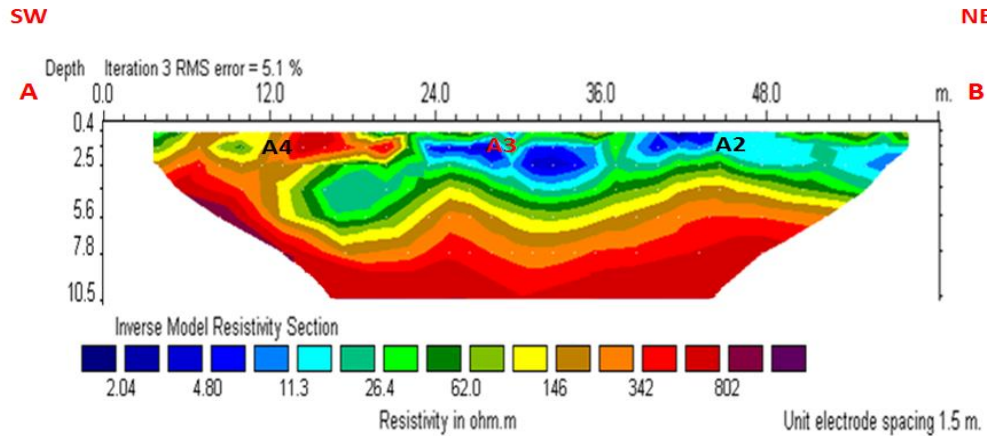
Fig. 5: Resistivity Tomography Pseudosection for Profile AB

The result of the 2-D electrical resistivity tomography data along profile AB (Figures 5) suggests that the subsurface at shallow (foundation) depth has less dense/loose or low resistivity soil layer at about the centre of the spread, flanked by dense/compacted or high resistivity soil layers. The delineated low resistivity soil layer at about the centre of the spread is overlain by the amplitude of the observed trough of the gap between the building's wall and floor.

The results of the geotechnical test suggests that the layer of the soil directly underlying the building at A3 (Figure 5) has less bulk density and specific gravity than A2 and A4. This suggests that a loose soil layer is flanked by compacted soil layers. Owing to difference in texture and high moisture content of A3 relative to A2 and A4, it is a weak zone which resulted to the subsidence of the floor overlying it. Based on the interpretations given in the foregoing, a model was put forward for the structural failure of the building on profile AB. The model is presented in

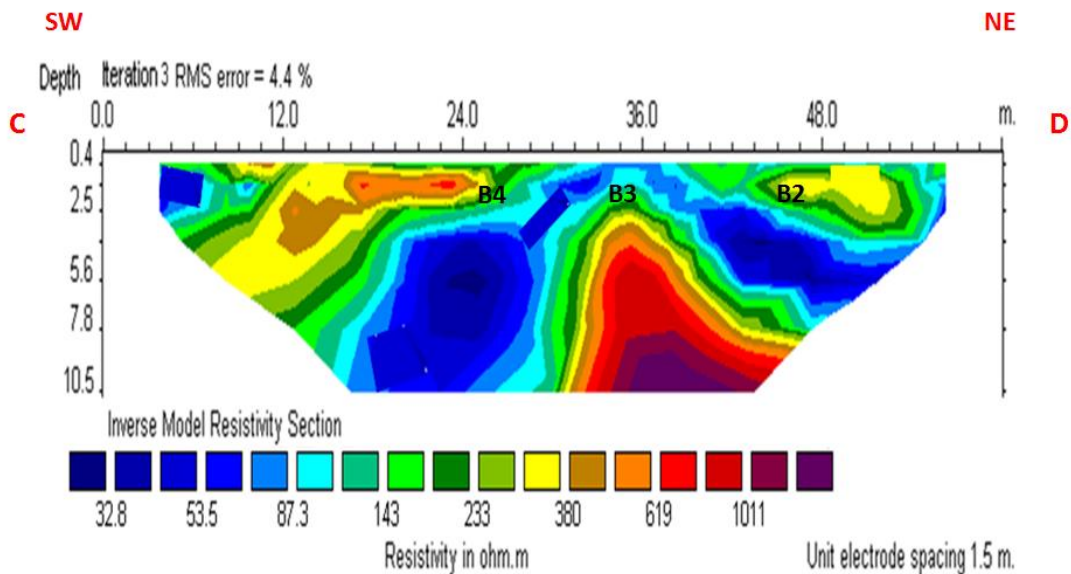
Fig. 6: Resistivity Tomography Pseudosection for Profile CD

The results of the geotechnical tests of the soil samples collected from B2, B3 and B4 along profile CD (Figure 6) suggest that the layer of the soil directly underlying the building at B3 has higher bulk density and specific gravity than B2 and B4. This suggests that a compacted soil layer is flanked by loose soil layers. These differences in soil compaction laterally most likely led to differential settlement of the building. The diagonal crack most likely was caused by the resistance the underlying soil layer (Coarse Sand) offered to the building's

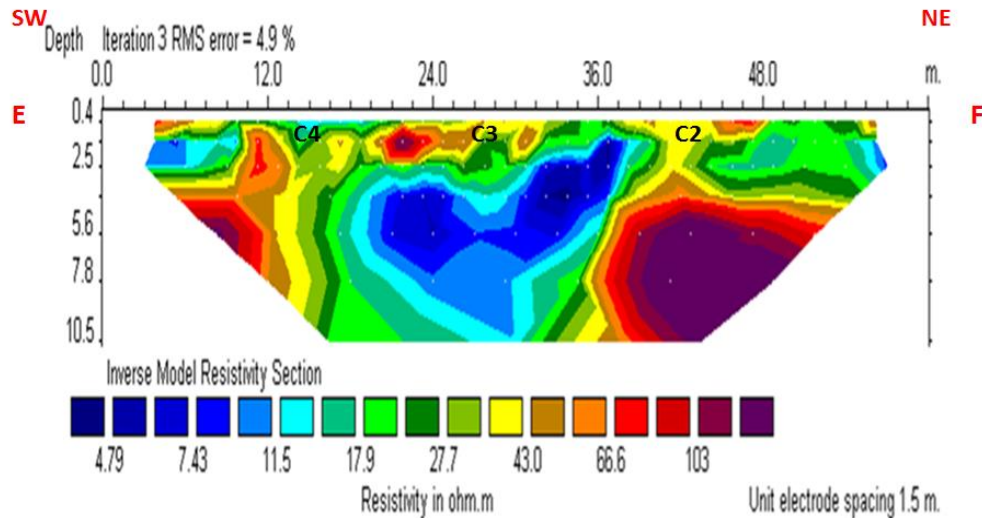
Fig. 7: Resistivity Tomography Pseudosection for Profile EF

The resistivity range deduced from the 2-D electrical resistivity tomography data along the profile (Figures 7), when compared with the range, 1 – 100 Ω m, usually associated with clays, Telford *et al.* (1976) and Osemeikhian and Asokhia (1994) suggests that the subsurface at shallow (foundation) depth is predominantly clay. This further suggests that the anomalous zones are underlain by clay and clayey formations. The clay rich soil had resulted to creepy ground movement due to seasonal swells and shrinkages of the soil. This mechanism created the observed floor creaking.
