Geophysical and Geotechnical Examination of Structural Failure in Federal University Otuoke, Nigeria

Ibe, S.O. and Anekwe, U. L.

Department of Physics, Federal University Otuoke, Nigeria

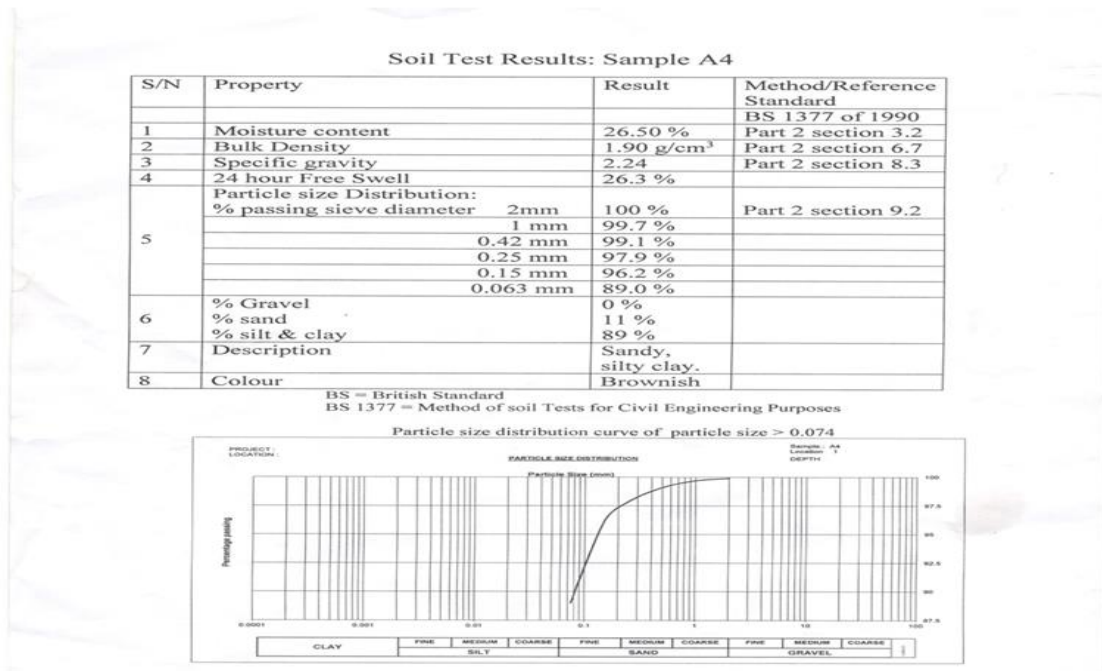
Fig. 8: Results of Geotechnical Test of a Soil Sample in the Study Area

The results of the geotechnical test suggests that the layer of the soil directly underlying the building at A3 (Figure 5) has less bulk density and specific gravity than A2 and A4. This suggests that a loose soil layer is flanked by compacted soil layers. Owing to difference in texture and high moisture content of A3 relative to A2 and A4, it is a weak zone which resulted to the subsidence of the floor overlying it. Based on the interpretations given in the foregoing, a model was put forward for the structural failure of the building on profile AB. The model is presented in
